SITE REUSE ASSESSMENT

Associated Electric Site
171 West Main Street

Town of Hillsborough, NH

UConn TAB

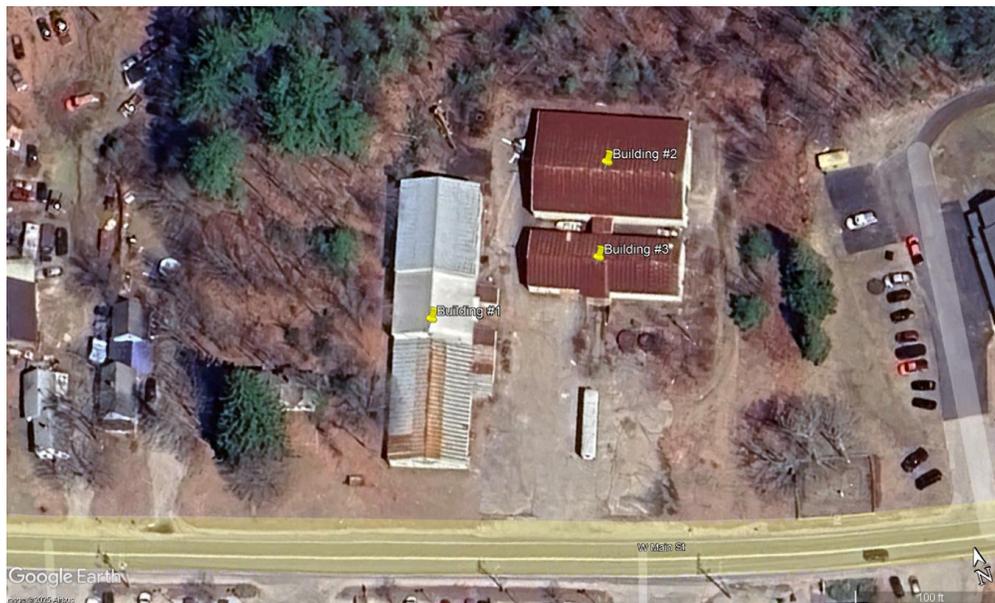
Figure 2. Map of On-Site Buildings (Source: Google Earth Pro)

As seen in **Figure 2**, there are currently three buildings on the Site. Building #1, built in 1970, is 9,000 ft² and located on the southwestern border of the parcel. Building #2 was built in the early-1990s and is 5,000 ft², oriented perpendicular to Building #1. Building #3 was constructed in the mid-1980s, is 3,500 ft², and is located directly south of Building #2.

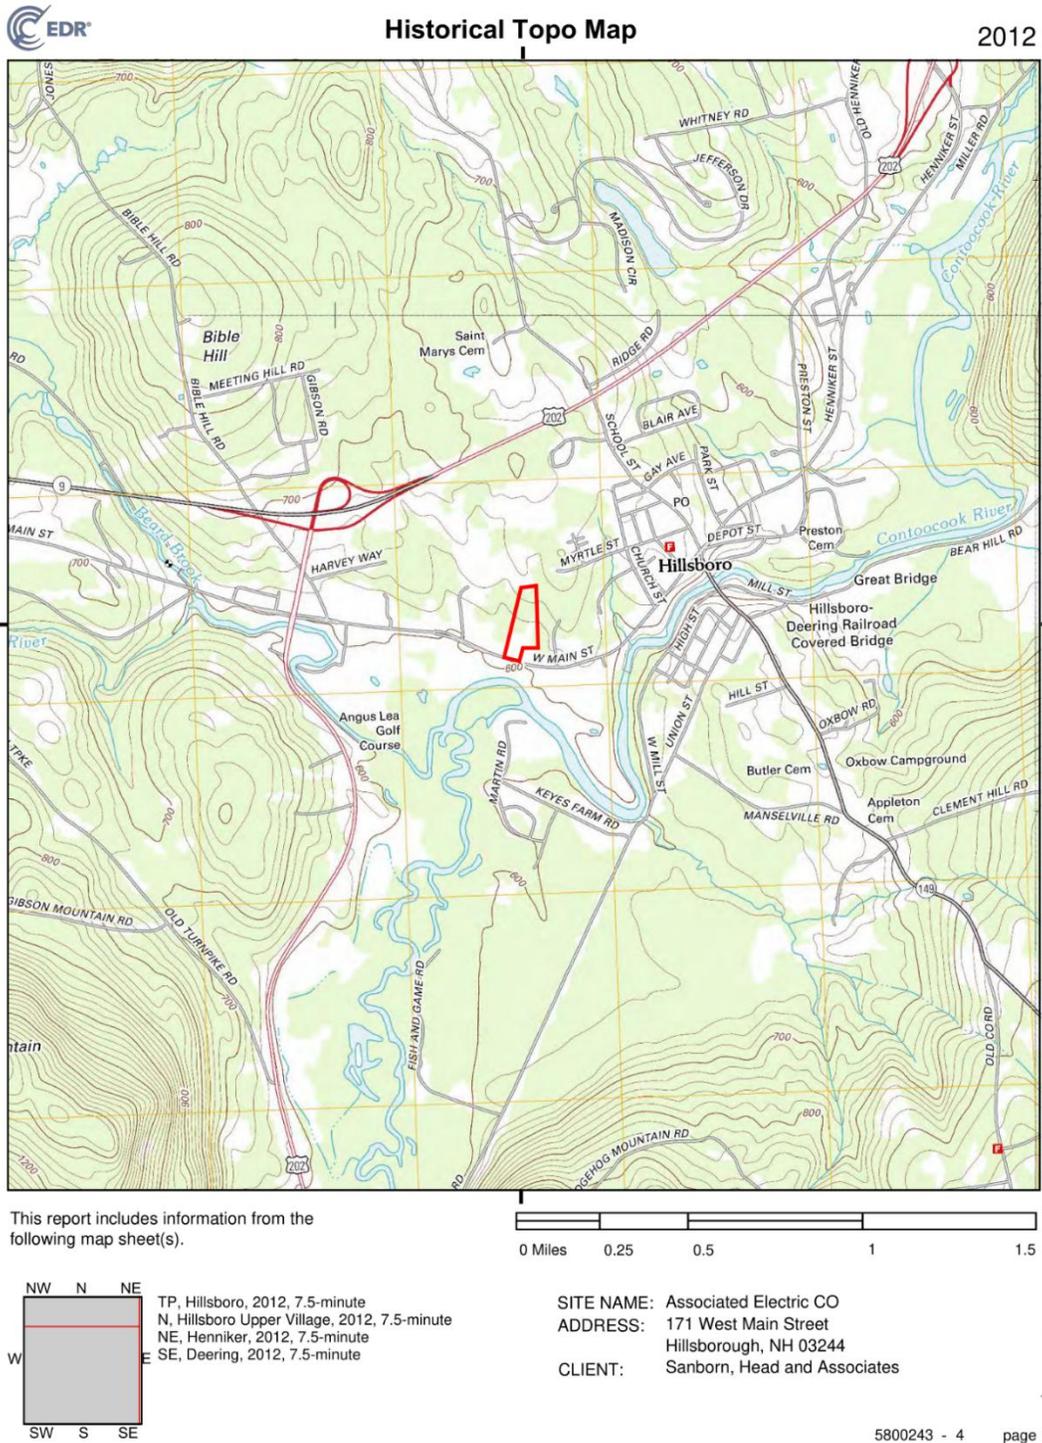
Figure 3. Topographic Map of Area of Site [Parcel Boundaries Marked] (Source: Sanborn, Head & Associates, LLC)

runoff and groundwater flow are inferred to flow from the area of the landfill in the general direction of the Site.

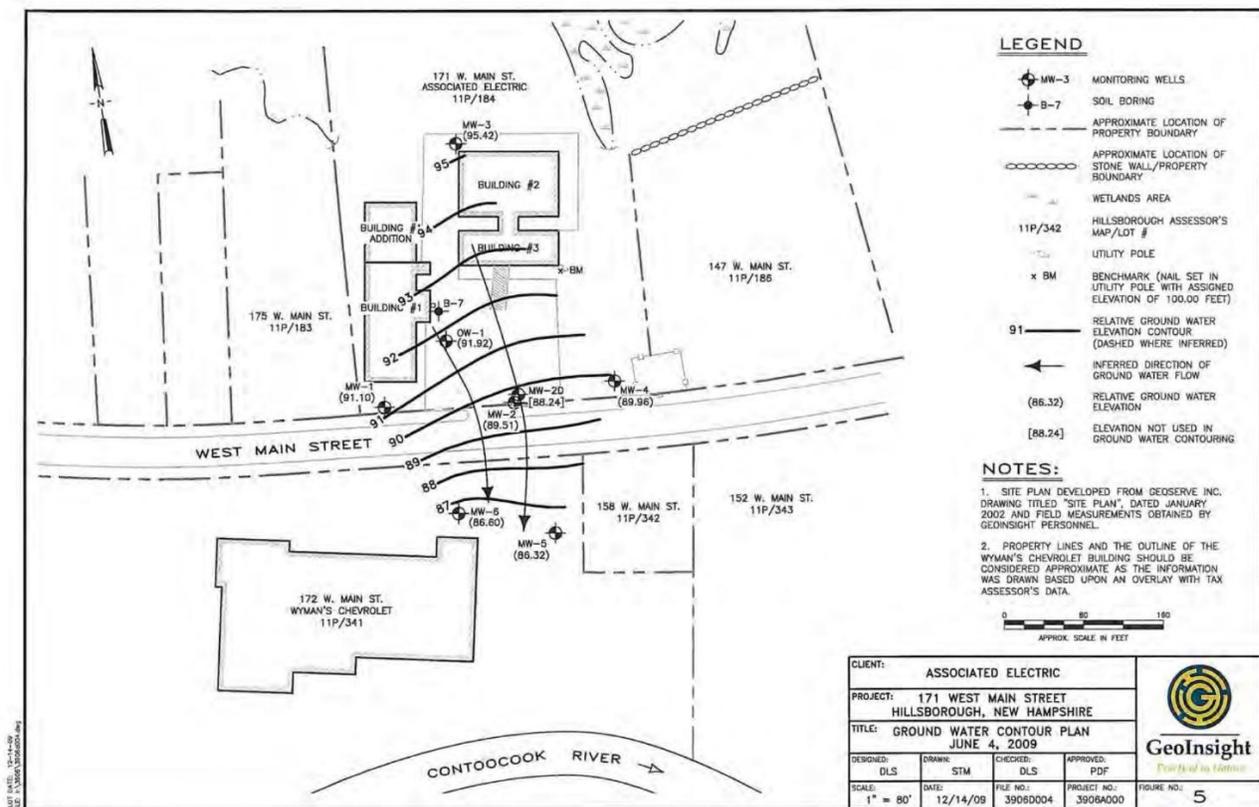
Figure 4: Groundwater Flow Map (Source: Phase I ESA, 2020)

The Contoocook River is located 340 ft south of the site, and surface water and groundwater at the Site flow toward the river (**Figure 4**). Additionally, a small stream enters the Site to the northwest of Building #1 (**Figure 5**). There is an 18-inch reinforced metal pipe culvert that reportedly carries water below ground to a point northeast of Building #2 and discharges to an open drainage trench where the water enters a second culvert and flows southerly to a catch basin (CB-1 in **Figure 5**). Stormwater generally flows through a series of drainage pipes from northwest to southeast across the property. There is also a catch basin (CB-3 in **Figure 5**) located between Buildings #1 and #2. Stormwater entering this basin flows through a drain line to CB-1. These pipes are reportedly not efficient and the Site experiences frequent flooding which can cause one to two feet of standing water in Building #1 during significant storm events. Additional discussion of the existing drainage network at the Site can be found in Section 7.

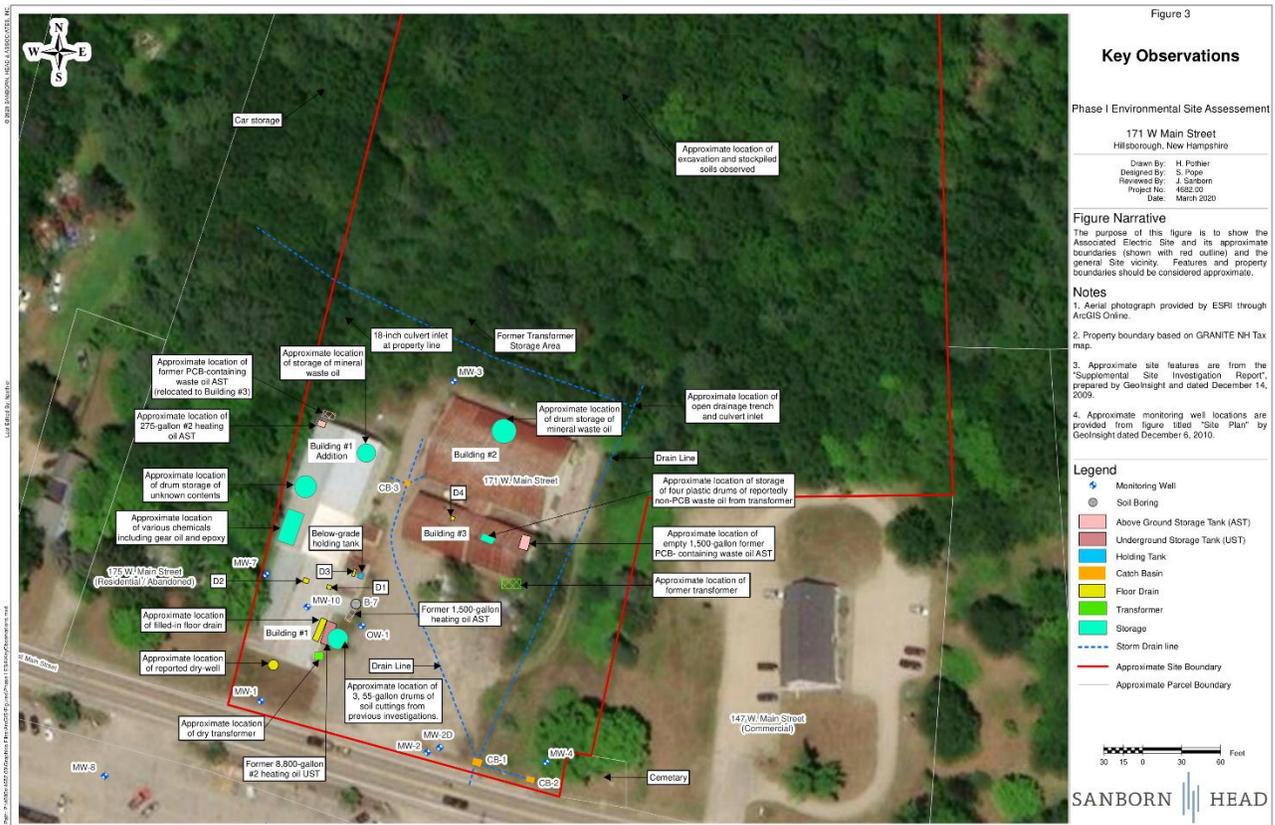
Figure 5. Key Observations Map from Phase I ESA (Source: Sanborn, Head & Associates, LLC. 2020)

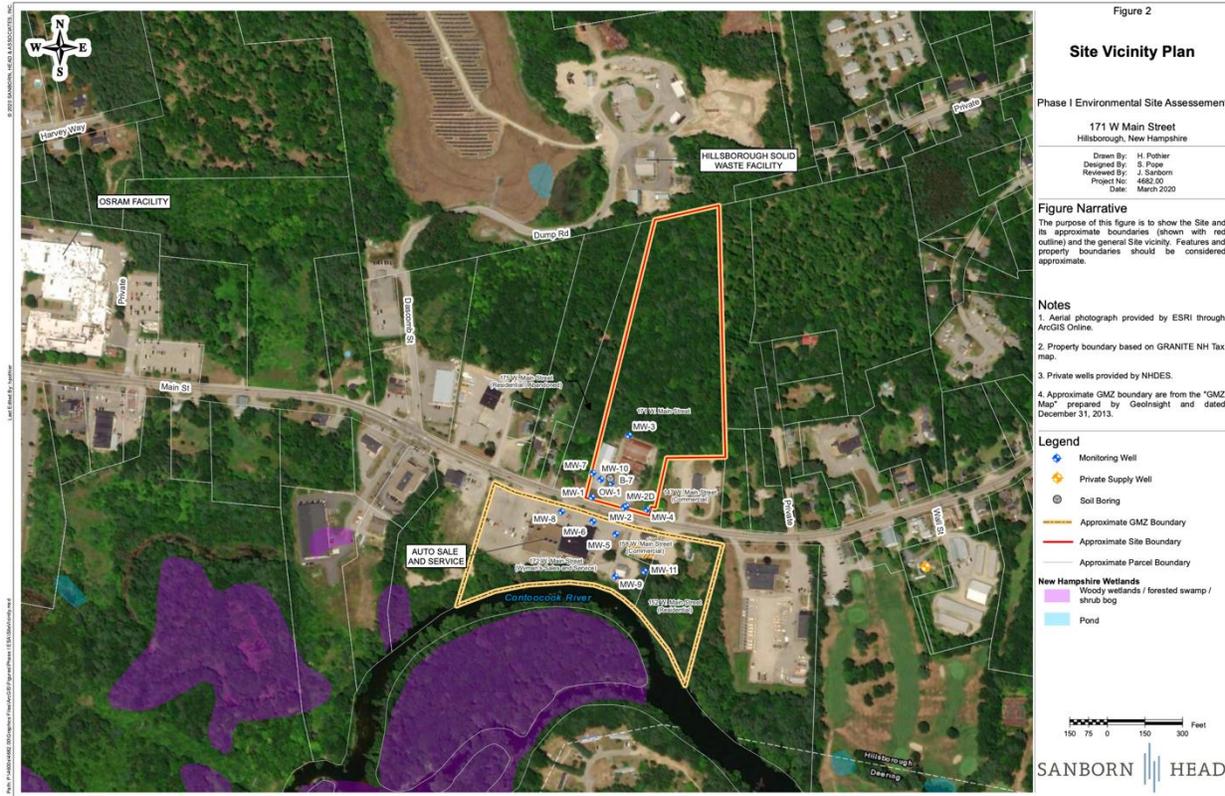
Figure 13. Annotated Map of Wells and Floodplains in the Vicinity of the Target Site (Source: Sanborn Head, 2019)

While the Target Site itself is not located within a floodplain, as mapped by the Federal Emergency Management Agency (FEMA), there are floodplains south of the Site on the opposite side of West Main Street associated with the Contoocook River (**Figure 13**). The 500-year flood zone (0.2% annual chance flood hazard area) is within about 130 feet of the Site; the 100-year flood zone (1.0% annual flood hazard area) is within about 500 feet of the Site. It is also important to note that the ground surface of the property can flood during significant storm events despite not being directly located within the floodplain; Building #1 floods with one to two 2 feet of standing water during significant storm events due to inefficient on-site stormwater management systems (see Section 7).

floodplain in the future, based on distance from the Site, and overall groundwater flow direction in the vicinity of the Site [towards the river], flooding is not anticipated to have a major impact on proposed remedial alternatives for the Site. However, localized ponding and/or flooding observed in the vicinity of Building #1 may need to be considered as part of future redevelopment designs.”

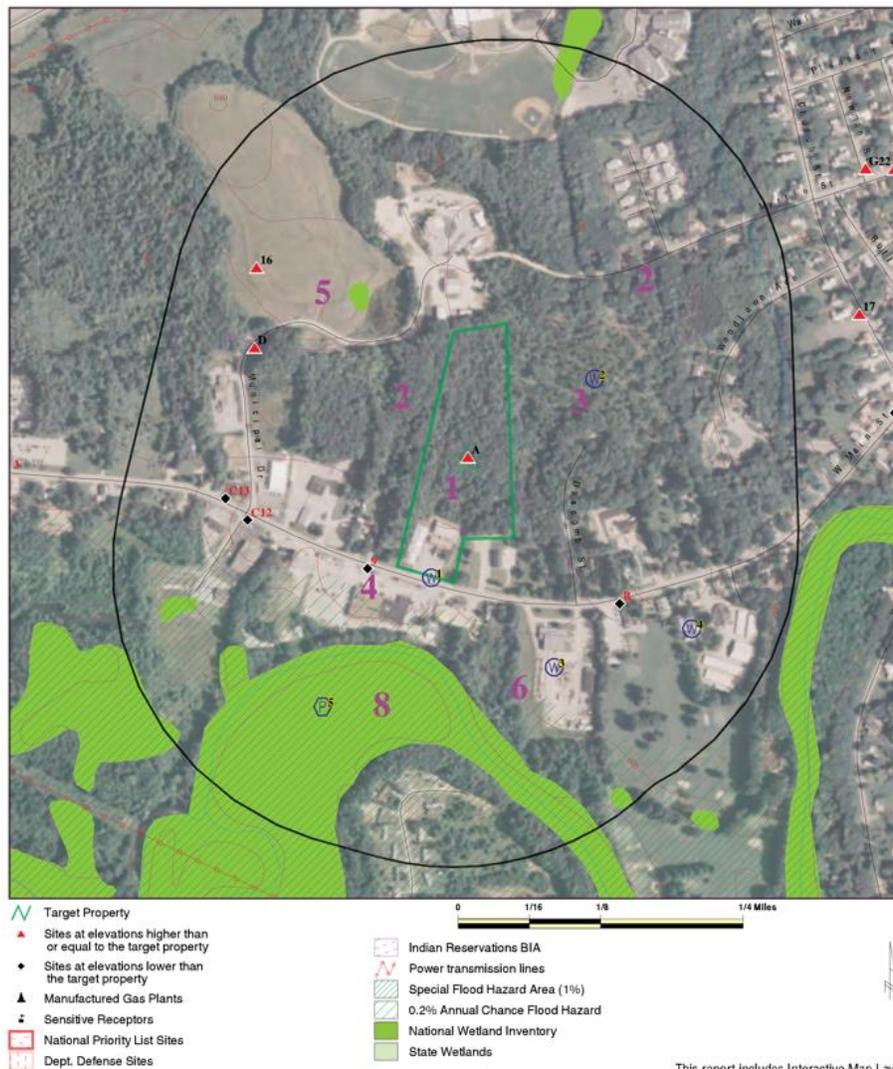
Figure 14. Annotated Wetlands Map with Key, Showing Onsite and Offsite Monitoring Wells (Source: Sanborn, Head, & Associates, 2020)

As seen in **Figure 14**, there are no wetlands located on the Target Site. However, there are woody wetlands/forest and a swamp/shrub bog located south of the Site along the banks of the Contoocook River. As previously mentioned, the Site is directly upgradient of the river, so adequate stormwater management is vital to ensure that runoff from the Site does not discharge into the river and impact bordering wetland areas.

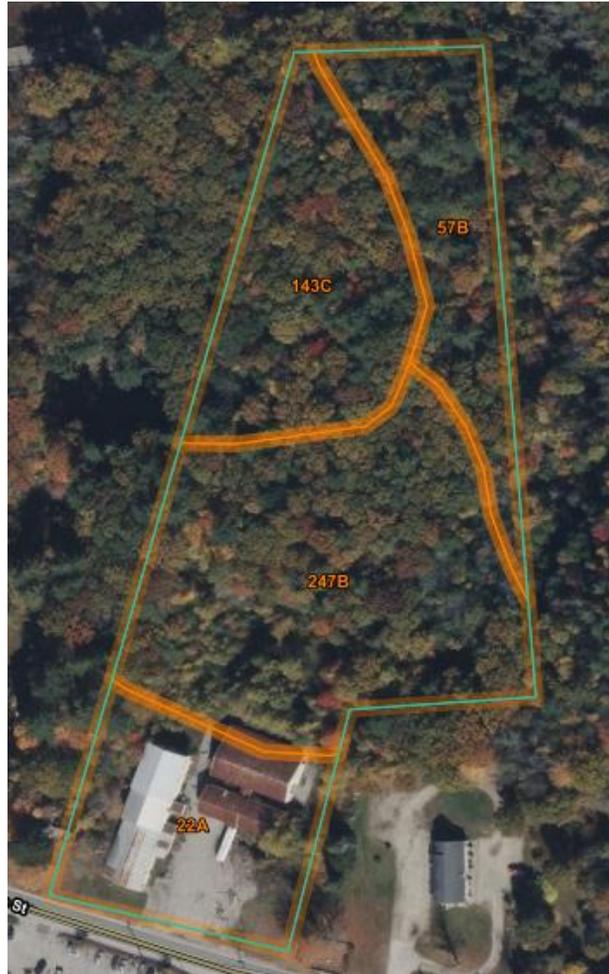
Figure 15. Site Soil Unit Map (Source: NRCS WSS)

Soil Map Unit Name (Map Unit Symbol)	Colton gravelly sandy loam, 0 to 3 percent slopes (22A, 2ym4j)	Becket fine sandy loam, 0 to 8 percent slopes, very stony (57B, 2w9pn)	Monadnock fine sandy loam, 8 to 15 percent slopes, very stony (143C, 2wlm7)	Lyme fine sandy loam, 0 to 8 percent slopes, very stony (247B, 2trsd)
Approx. Percentage of Site Land Area	19%	17%	22.3%	41.8%
Hydric Soil	No	No	No	Yes
Hydrologic Soil Group	A	C	B	B/D
Drainage Class	Excessively drained	Well drained	Well drained	Poorly drained
Depth to Seasonal High Water Table	More than 80 inches	More than 80 inches	More than 80 inches	0 to 18 inches
Parent Material	Sandy-skeletal glaciofluvial deposits	Loamy lodgment till derived from granite and gneiss and/or schist over sandy lodgment till derived from granite and gneiss and/or schist	Loamy supraglacial meltout till derived from phyllite and/or granite and gneiss and/or mica schist over sandy and gravelly supraglacial meltout till derived from phyllite and/or granite and gneiss and/or mica schist	Loamy supraglacial meltout till derived from phyllite and/or granite and gneiss and/or mica schist

Restrictive Layer	Not specified	Densic material	Strongly contrasting textural stratification	Not specified
Depth to Soil Restrictive Layer	Not specified	21 to 43 inches	18 to 36 inches	More than 80 inches
Depth to Bedrock	>200 cm	>200 cm	>200 cm	>200 cm
Septic (SSDS) Absorption Suitability	Very limited	Somewhat limited	Very limited	Very limited
Restrictions to Septic (SSDS) Absorption	Filtering capacity & seepage, bottom layer	Slow water movement	Slope, slow water movement, & seepage, bottom layer	Depth to saturated zone, slow water movement, & seepage, bottom layer
Suitability for Building with Basement	Not limited	Not limited	Somewhat limited (Slope)	Very limited (Depth to saturated zone)
Suitability for Building without Basement	Not limited	Not limited	Somewhat limited (Slope)	Very limited (Depth to saturated zone)

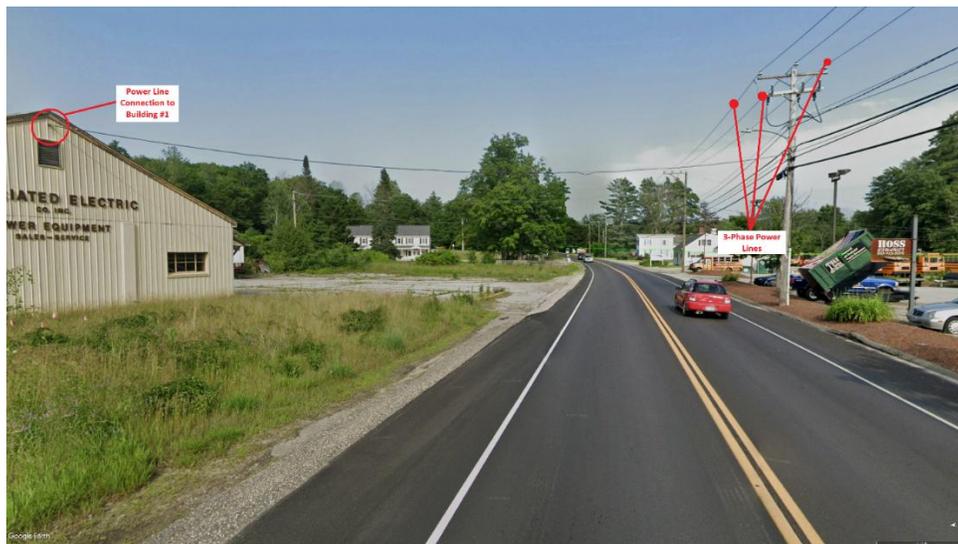
Figure 18: Power Lines Along West Main Street and Connected to Building #1 (Source: Google Earth Pro)

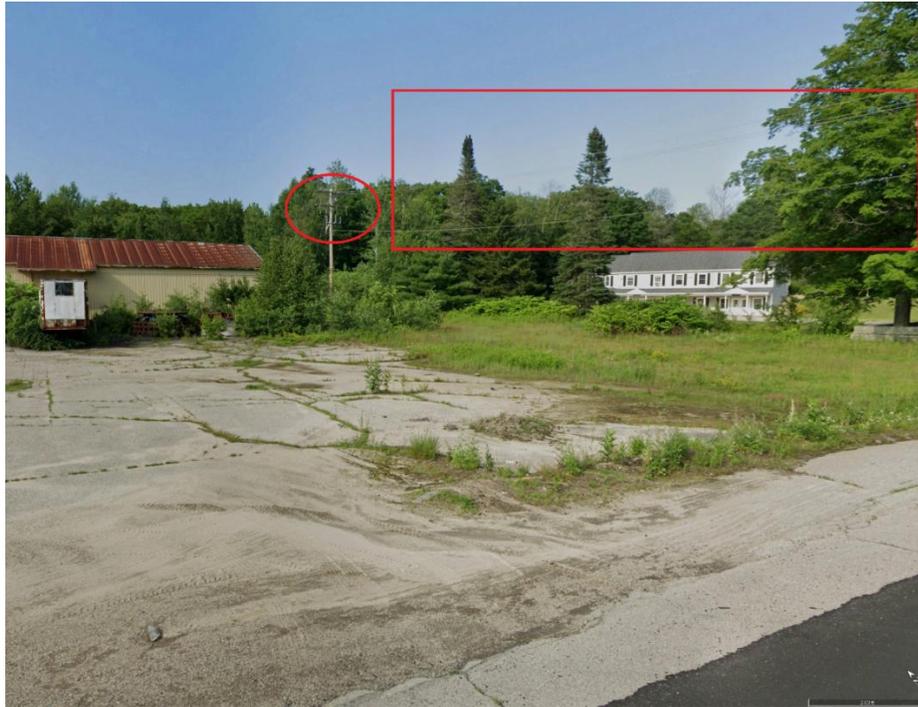
Figure 19. Power Lines Along Eastern Target Site Boundaries (Source: Google Earth Pro)

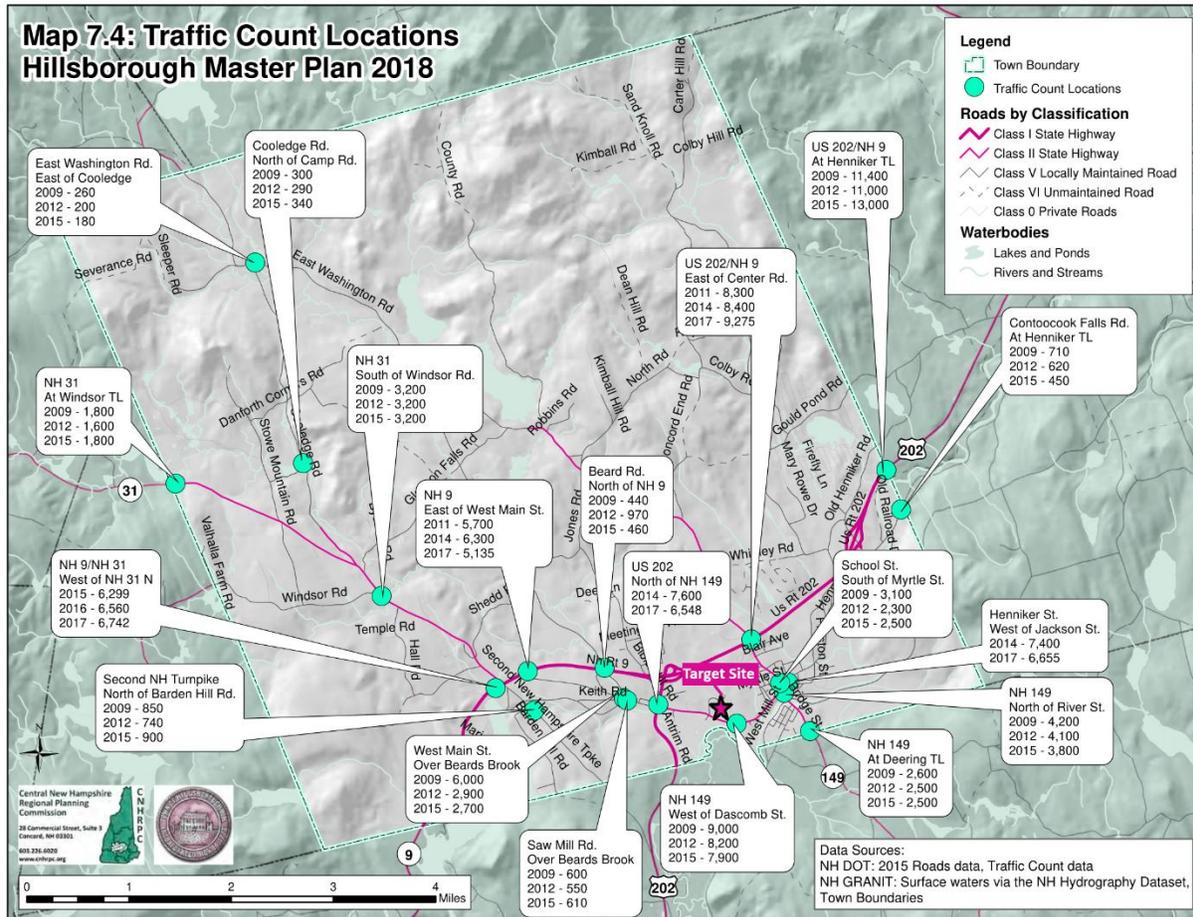
Figure 21. Traffic Count Locations in Hillsborough (Source: Hillsborough Master Plan, 2018)

Shown in **Figure 21**, the Site is in one of the most highly trafficked areas in Hillsborough. On NH-149 just east of the Site and west of Dascomb Street, the most recent AADT count was 7,900 and just west of the Site at the West Main Street-Antrim Road intersection, the AADT count was 6,538. This is beneficial for commercial developments in the area but is an important consideration for municipal Site reuses—entrances, exits, and other on-site road connections should be designed to allow efficient movement of emergency vehicles in and out of the Site. Additionally, considering the Site’s proximity to Municipal Road and the Hillsborough PD building, a connection between the Site and Municipal Road may be beneficial to mitigate traffic on West Main Street and provide more direct connections between the Site, the PD building, and other municipal services connected to Municipal Drive such as the transfer station complex, school complex, Town Hall, and FD building.

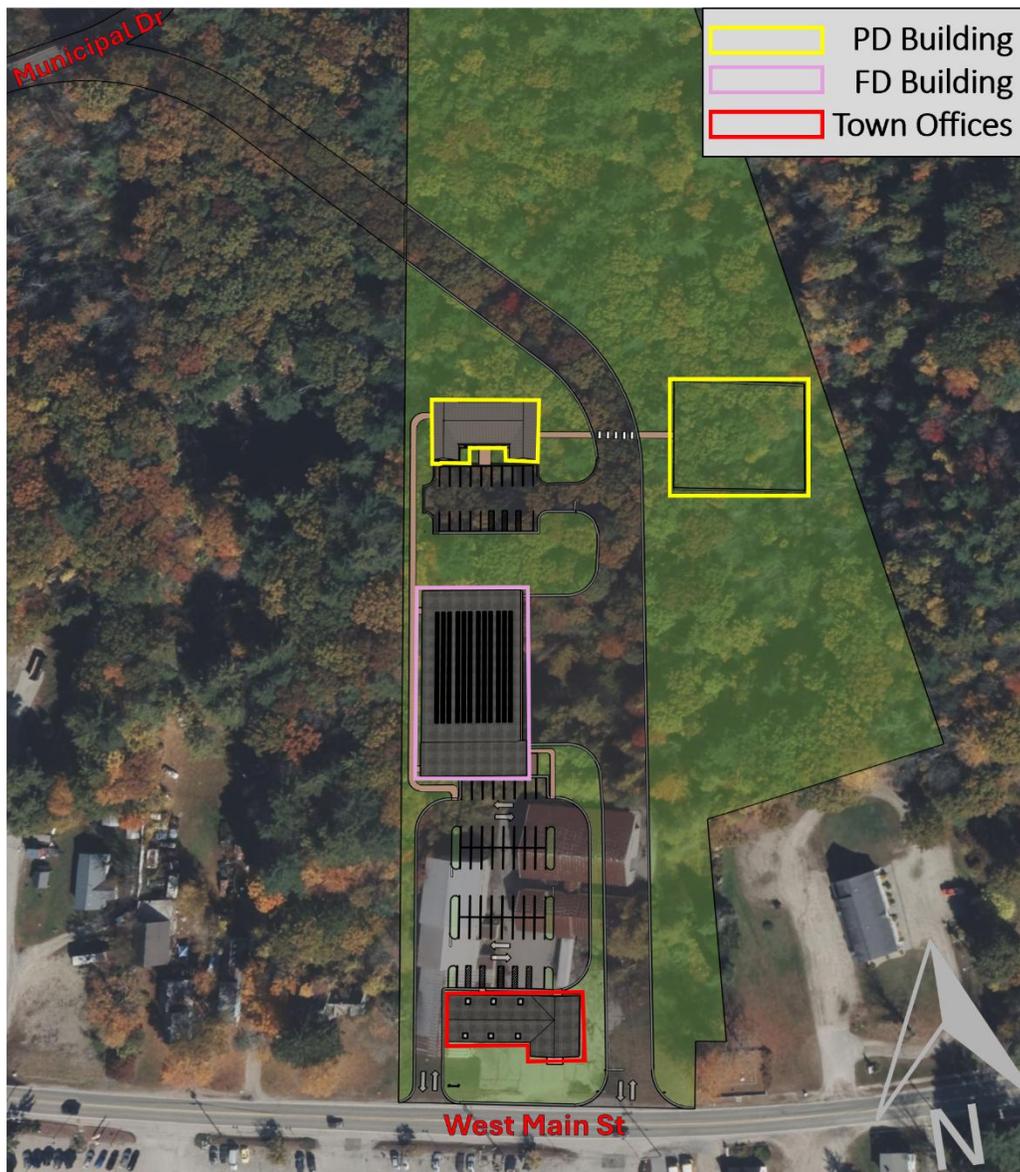
Figure 24. Annotated Aerial View of Reuse Scenario A (Sketchup)

Reuse Scenario A outlines a north-south linear building orientation and includes a vehicular connection between Municipal Drive and West Main Street (**Figure 24**). Adequate signage for parking areas and entrances/exits are included throughout. Landscaping and decorative flowers or assorted vegetation are also included throughout the Site, especially along building facades. Additionally, this Scenario includes a dedicated entrance for emergency vehicles, separate from an entrance for parking associated with the Town Offices.

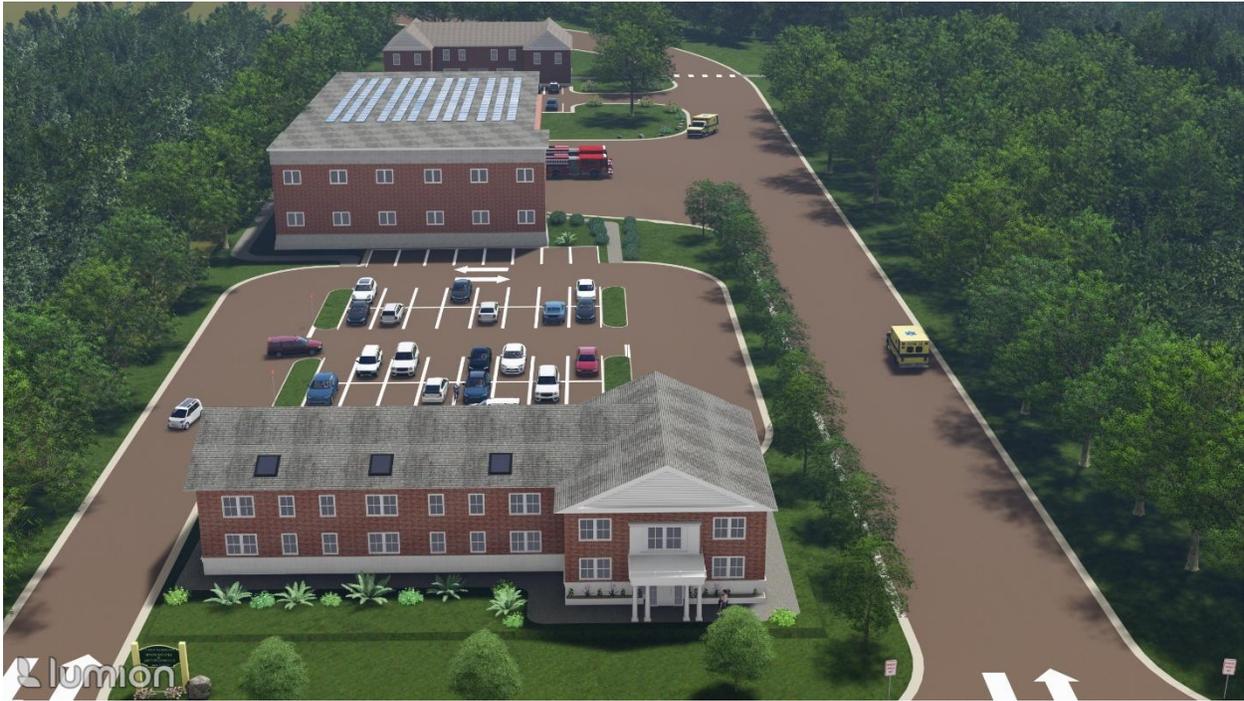
Figure 25. Scenario A: Aerial View of Site Layout (Facing N)

- o Shared parking lot with town offices building
 - o Rooftop solar panels
- Police Department Building
 - o 9,500 gsf 2-story building
 - o Minimal windows on 1st floor to maximize security for evidence storage

- o ~0.3-acre fenced outdoor training area
 - o Evidence and general storage space
 - o 14 parking spaces (in addition to 3 ADA-compliant handicap spaces)

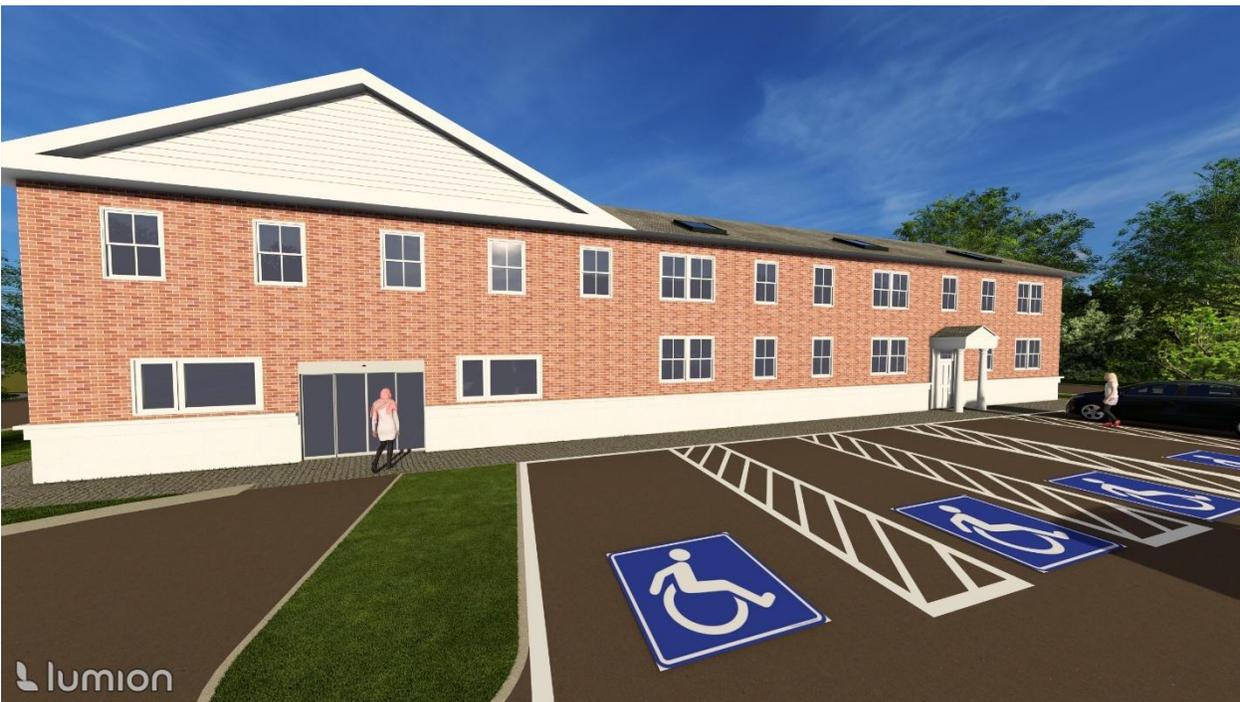
Figure 32. Scenario A: Town Offices Rear Entrance from Shared Parking Lot (Meeting space entrance on left & additional office space entrance on right; facing SW)

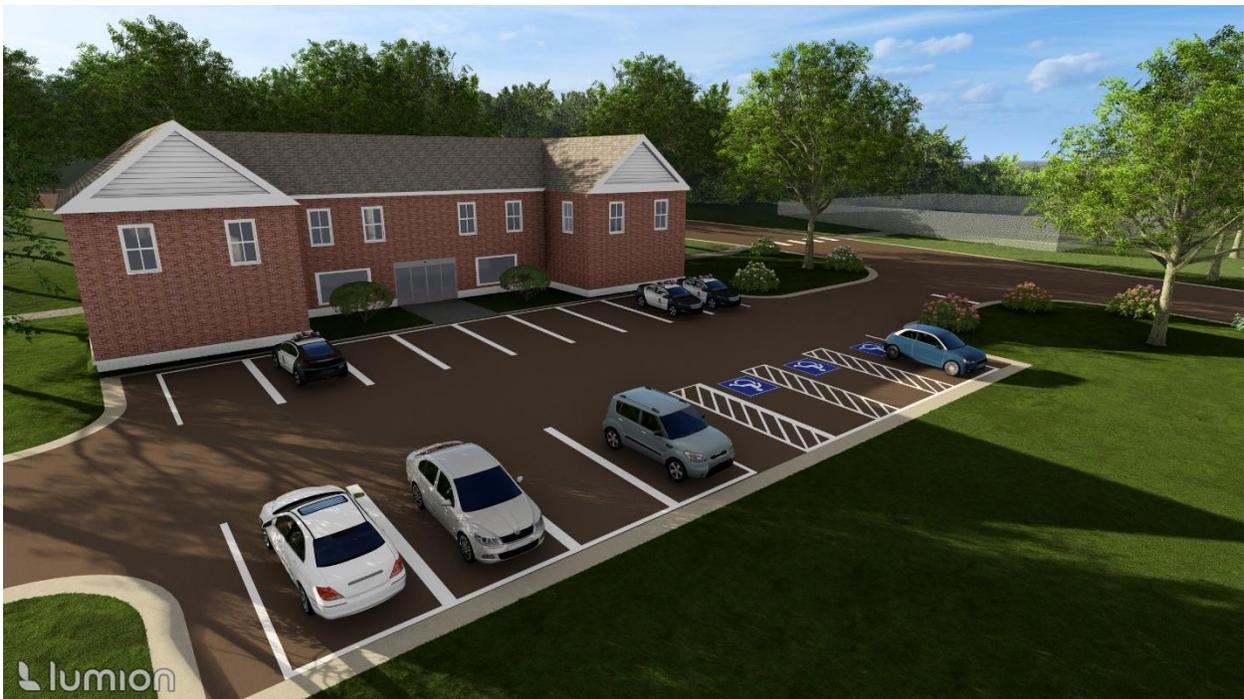
Figure 38. Scenario A: PD Building Parking Lot (Training area in top right; facing E)

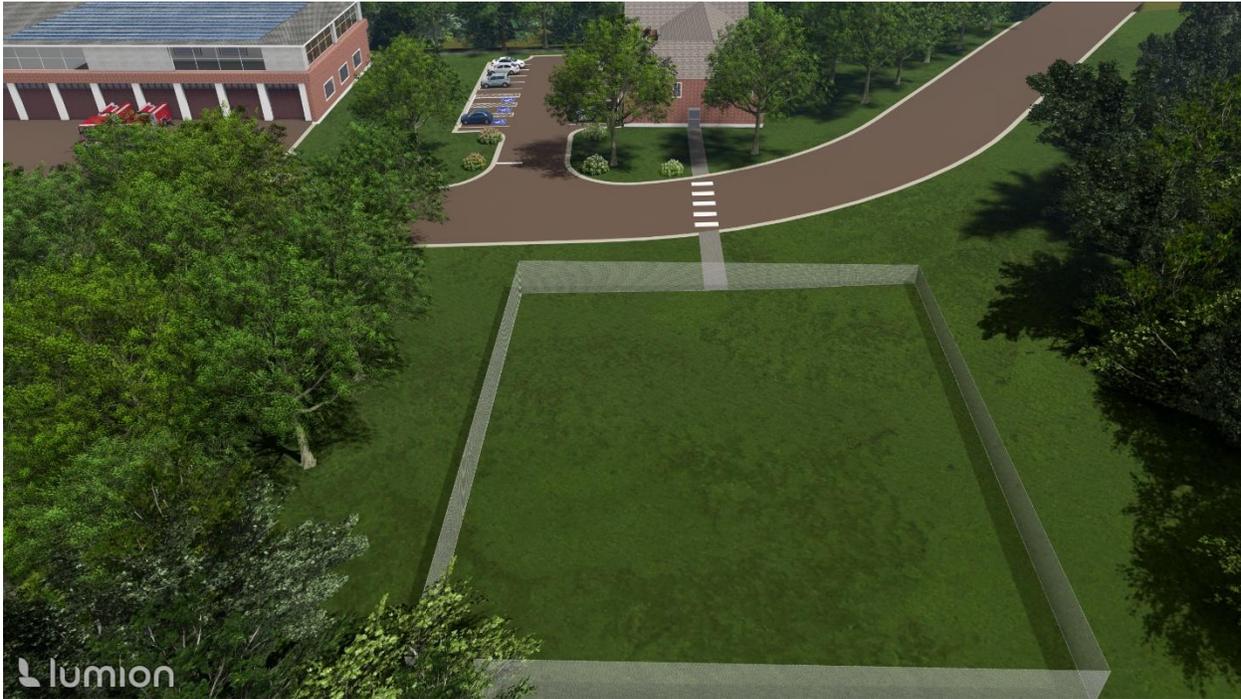
Figure 39. Scenario A: Birds' Eye View of Police Training Area (Connection to Municipal Drive in top right; facing W)

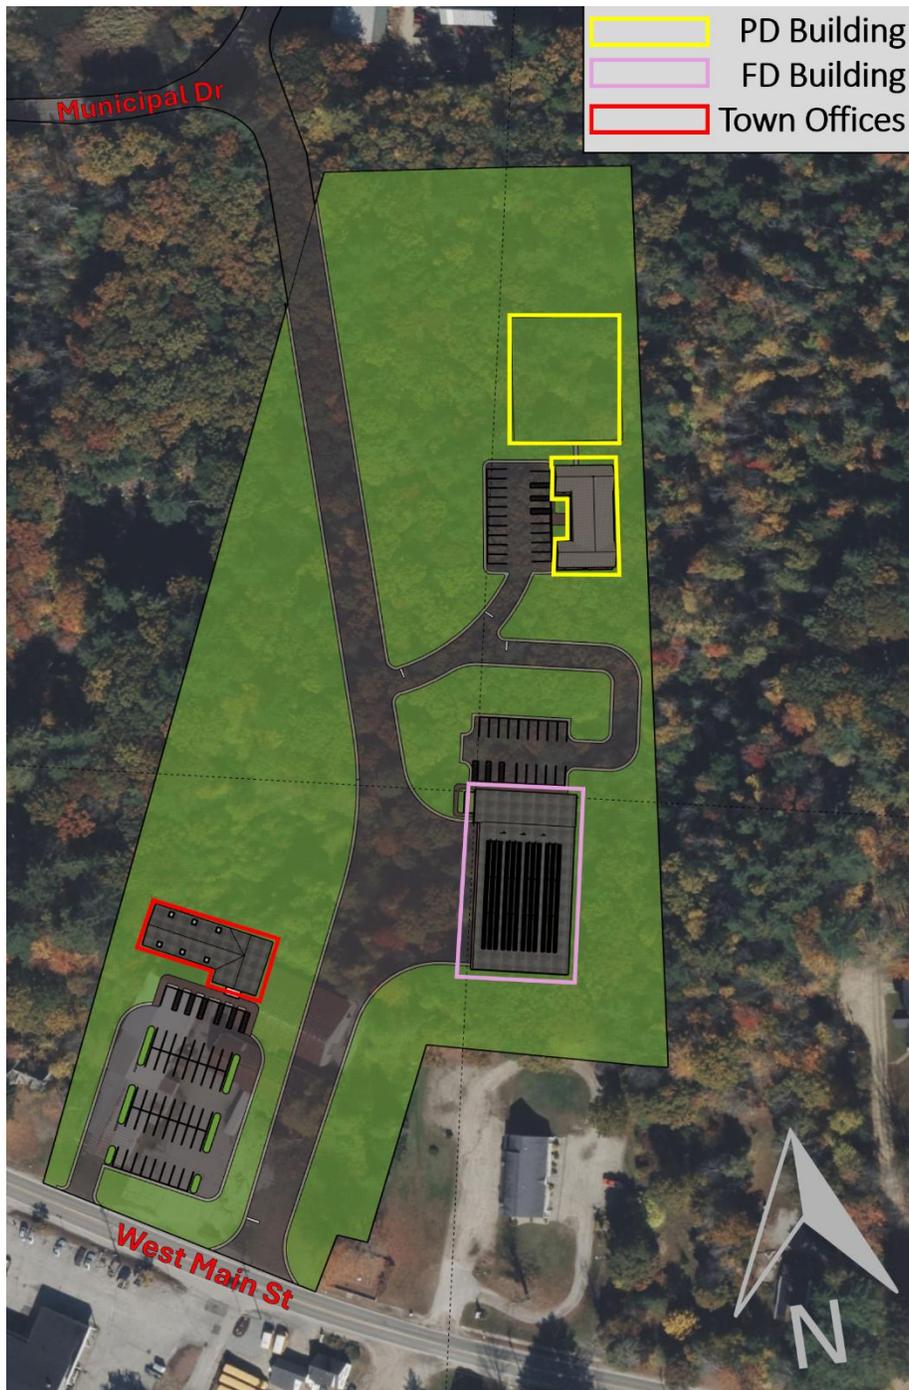
Figure 40. Aerial View of Reuse Scenario B (Sketchup)

While this layout slightly increases impervious surface coverage compared to Scenario A, as the Town Hall and Fire Department do not share a parking lot, this layout allows for additional green space in between on-site buildings and provides more separation between emergency services (i.e., fire and police department) and general municipal services at the Town Hall. Like Scenario A, Scenario B includes a vehicular connection between Municipal Drive and West Main Street (**Figure 35**). Adequate signage for parking areas and entrances/exits are included throughout. Landscaping and decorative flowers or assorted vegetation are also included throughout the Site, especially along building facades. Additionally, this Scenario also includes a dedicated entrance for emergency vehicles, separate from an entrance for parking associated with the Town Offices.

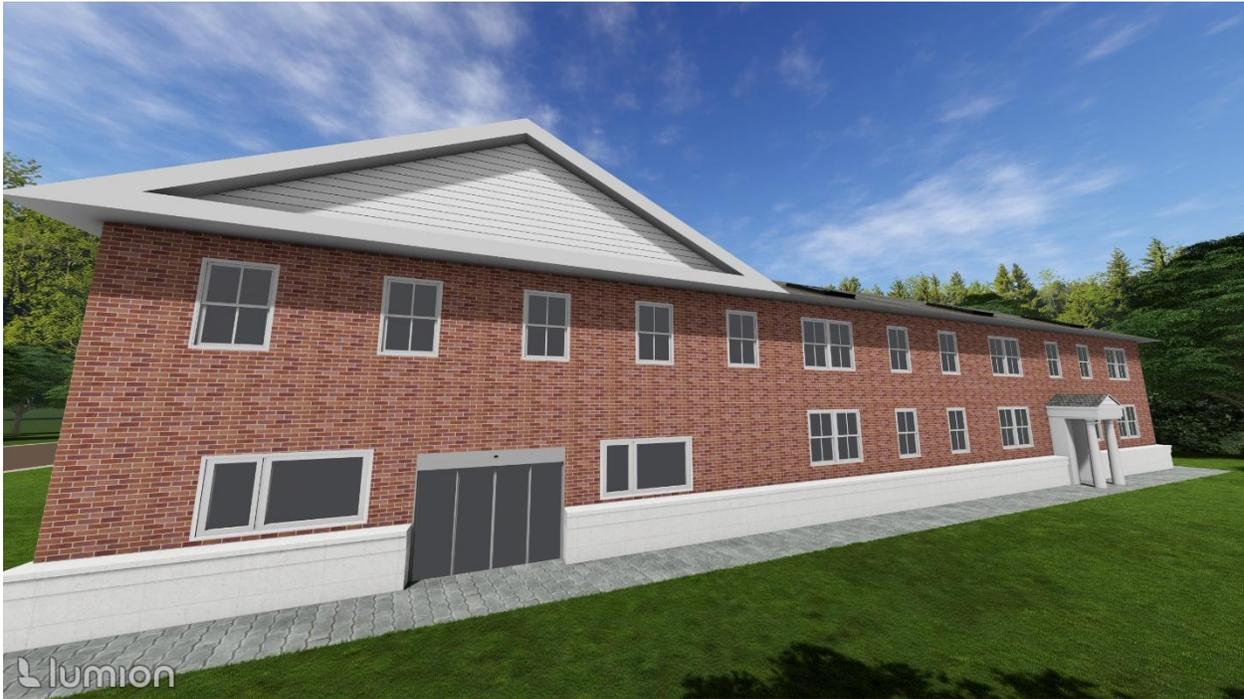
Figure 47. Scenario B: Town Office Building Rear Entrances (Meeting space entrance to left & alternative offices entrance to right; facing S)

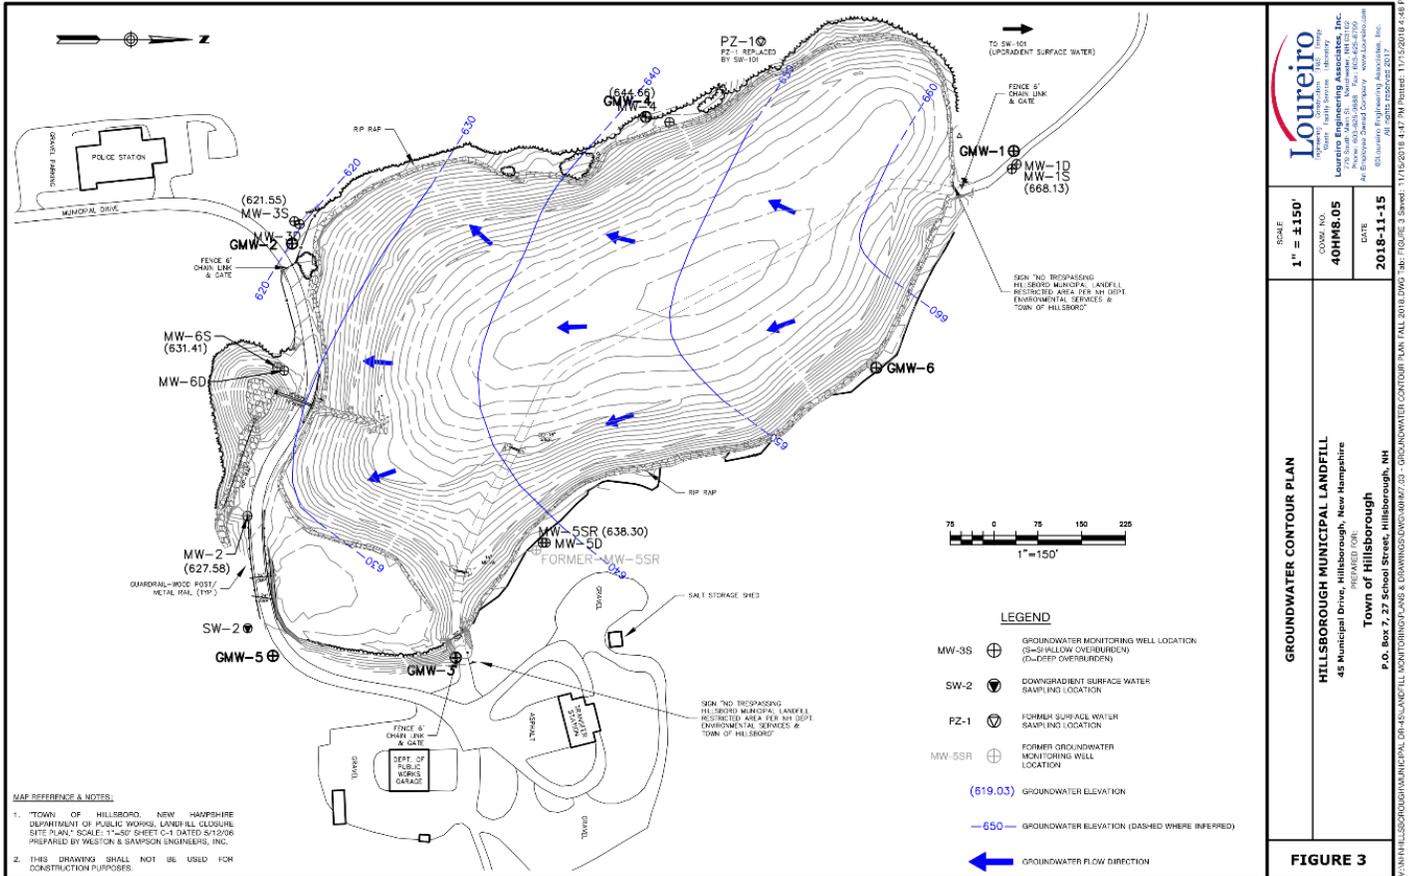
Appendix B. Topographical Map of Hillsborough Landfill with Approximate Surface Water Flow (Source: 2020 Phase I ESA)
